UNDERGROUND TANK | INHIBITOR INJECTION & SLEEVE INSTALLATION | SEPTEMBER 2016

## Summary

- The storage tank is an underground tank, with a diameter of 42 m.
- The tank is left with a minimal amount of liquid for safety precautions, with the remaining volume left for the volume of crude oil for the section of pipeline.
- The space around the tank was designed to provide for a minimal work area, and thus was deemed to be a confined space. Precautions and measures were taken to ensure that all safety standards had been put into effect.

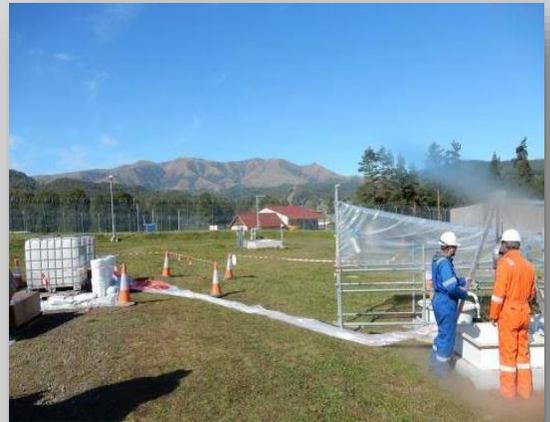
Inhibitor Injection Top Side

- After two full totes had been injected, it was decided that enough slurry had been added to the tank bottom. An amount of slurry was contained underneath the tank for almost two days. Initially, a rust colored solution had been displaced into the barrels. It was concluded that the inhibitor slurry helped to wash and rinse the bottom of the tank, removing any rusty buildup that had already appeared. Also, because there was a volume of water already inside the pit, it was not possible to determine how much slurry was been pumped out. The total volume of fluid removed from the area was approximately 750 gallons. Some slurry may be trapped inside cracks underneath the tank.
